Ministry of Livestock, Fisheries and Rural Development
Department of Rural Development
National Community Driven Development Project
IDA Grant: H813-MM

Final Report

Technical Audit

A review of technical quality of the Sub-Projects in
the first cycle of implementation

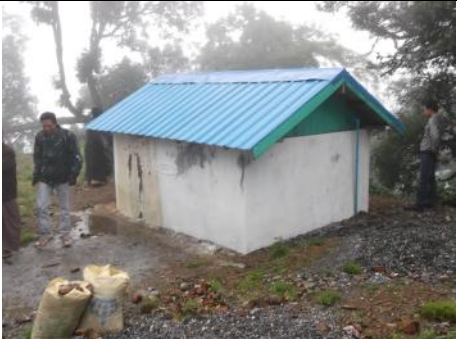
<p>Newly constructed reservoir. The tank is overflowing (it has no overflow pipe).</p>	<p>The water outlets (black pipe to the school, blue pipe to the village) are not protected and can be easily broken.</p>

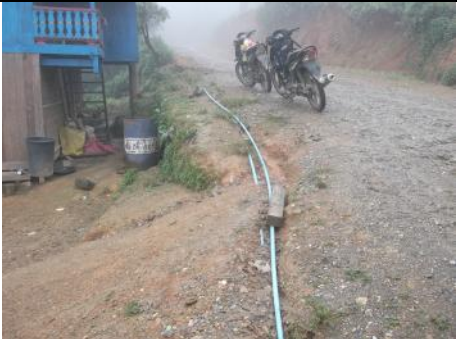
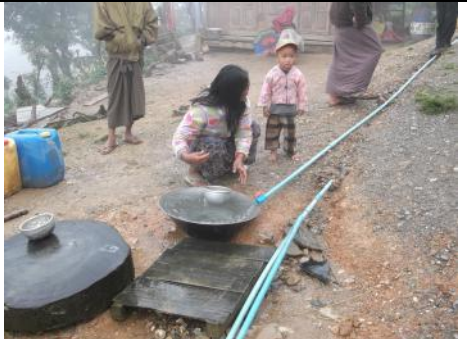
<p>In the village the old pipes are exposed along the road where water flowing along the road drains has eroded the soil.</p>	<p>No water tap stands were provided in the village, so the villagers take water from a disconnected pipe.</p>

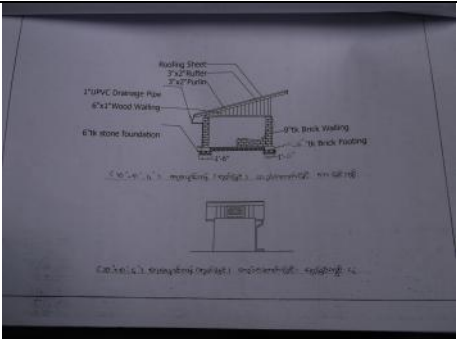
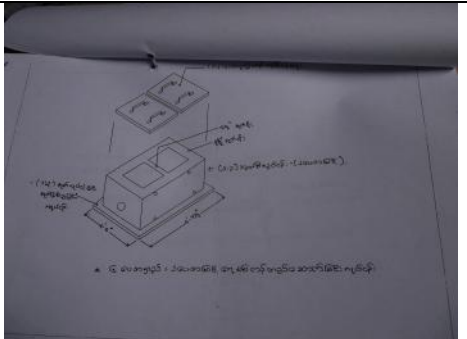
<p>Drawings of the reservoir show no details of pipe fixtures or overflow. The uPVC pipe shown in the drawing is for a gutter which was not constructed.</p>	<p>Drawings for filter with no piping details.</p>

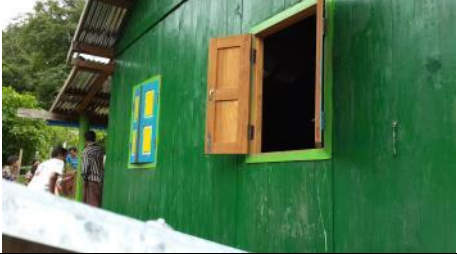
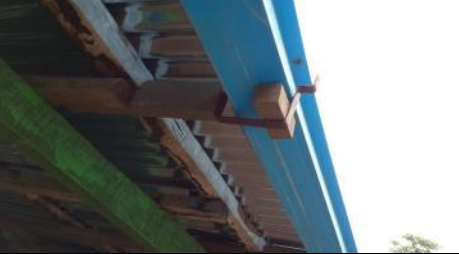
Good quality timber was used for the new windows.	The fixing of the gutter is not secure.

- Furniture must be provided by the community for the extension.
- The gutter should be securely attached to the brackets provided.

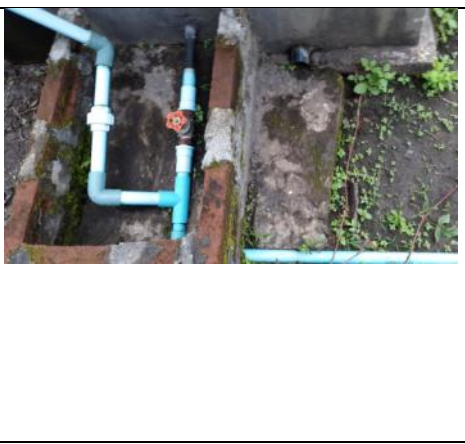
<p>Sketch of system showing location of the new reservoir</p>	<p>The reservoir overflow is connected to the pipe leading to the village tap stands in the existing system. If the tap is closed, the water will flow through the overflow, bypassing the tap.</p>

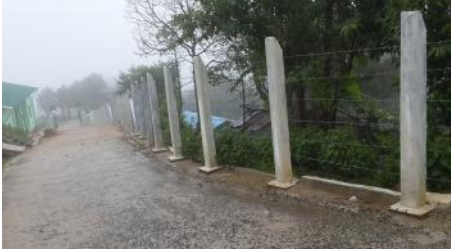
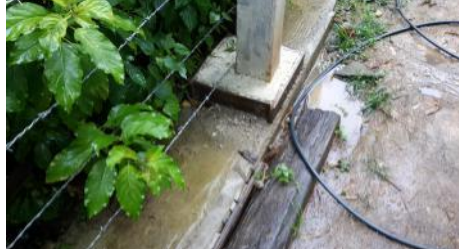
<p>Barbed wire school fence</p>	<p>The fence has a continuous foundation which is not required across the rear of the building. Money could have been saved to make the fence longer.</p>

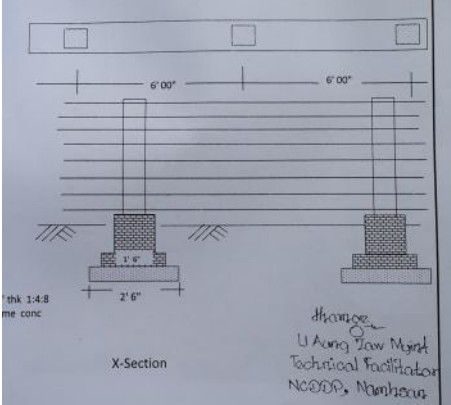
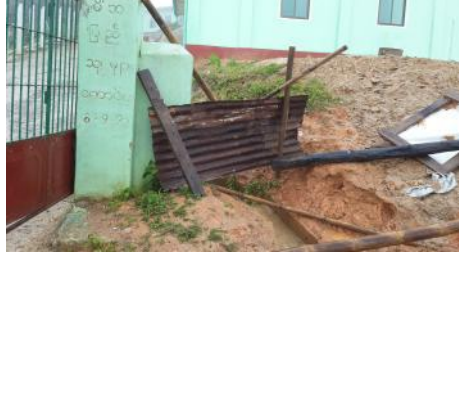
<p>The drawings appear to show discreet footings (bottom).</p>	<p>The fence must be extended around a newly constructed building.</p>

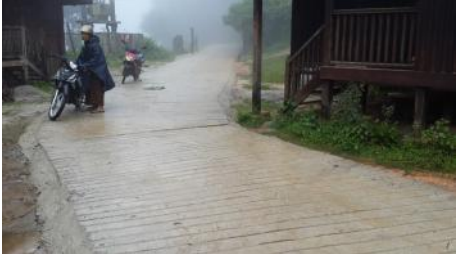
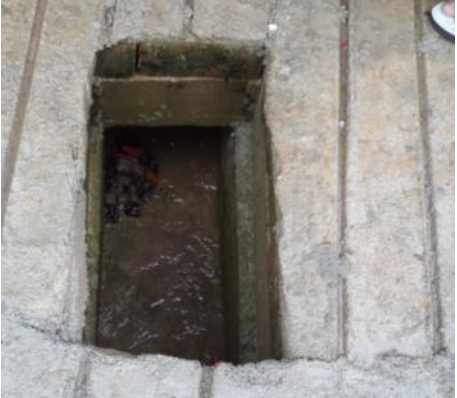
<p>Unreinforced concrete road constructed from the main road in the village to the health center.</p>	<p>A manhole cover is needed on this small drain.</p>

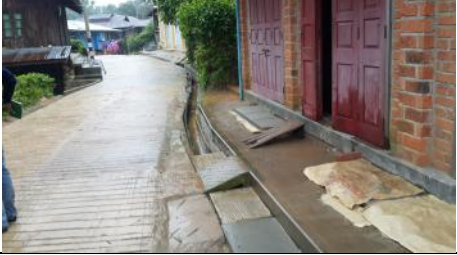
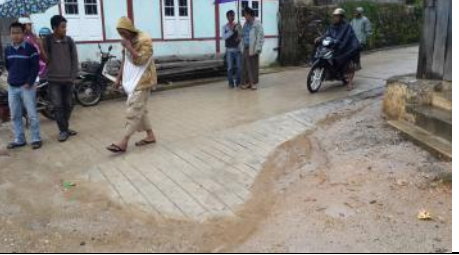
<p>Some sections had good side drainage; other sections need to be improved.</p>	<p>The entrance is sometimes used by heavy vehicles turning and should have been made from reinforced concrete.</p>

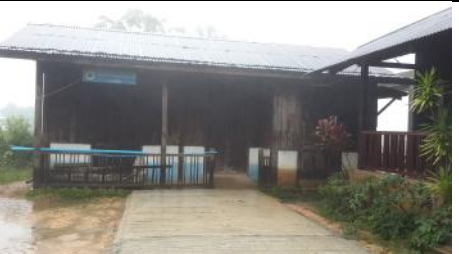
<p>This short section needs to be improved. The sides of the road should be planted with grass or covered with concrete.</p>	<p>There is no-place for vehicles to turn at the Health center.</p>

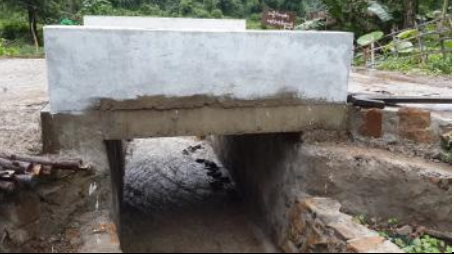
<p>Riprap protection of the stream bank. This may not last long but it should not affect the bridge.</p>	<p>Side view of bridge</p>

- It is necessary to repair the riprap along each side of the stream at the end of the rainy season every year.

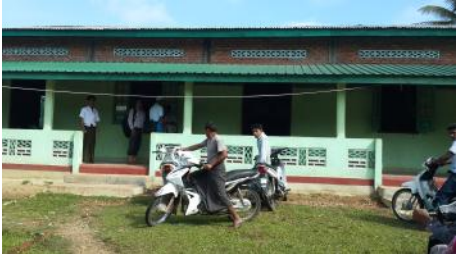
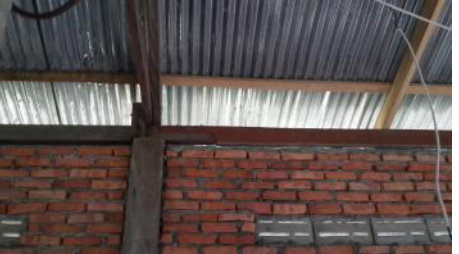
<p>Front view of renovated School</p>	<p>Inside was not plastered. The new room (extension) is on the right of the column shown.</p>

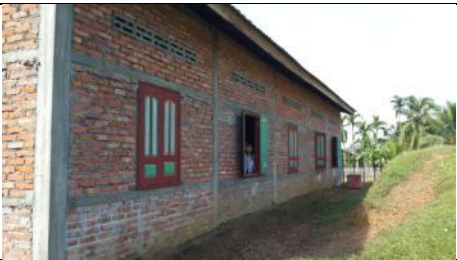
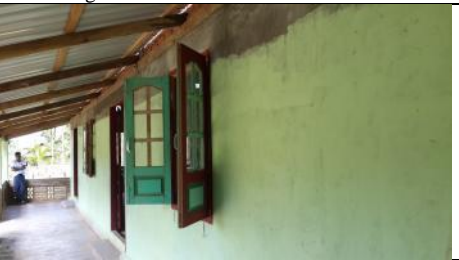
<p>Outside back and sides not plastered</p>	<p>Painting only to tops of windows</p>

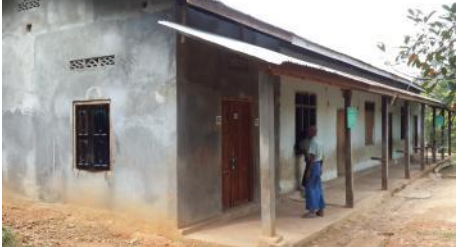
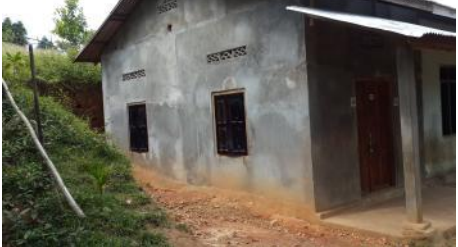
<p>Front view of school</p>	<p>Additional work is required to cut soil at rear of building where the new room was added.</p>

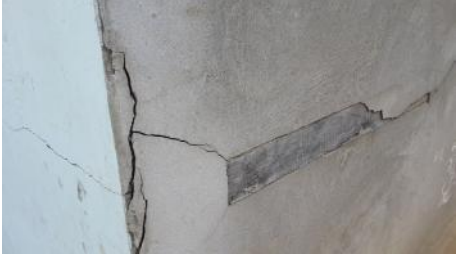
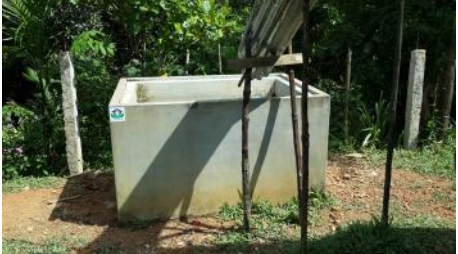
<p>Plaster is broken because it is not bonded to the timber structure.</p>	<p>Water tank showing gutter to collect rain water from roof.</p>

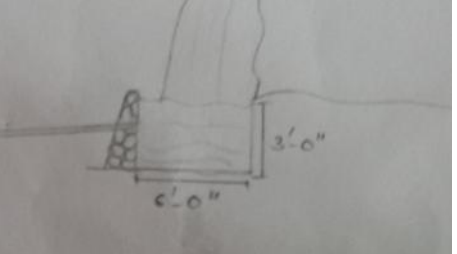
<p>Village meeting.</p>	<p>The drawing of the intake, showing the dam and outlet pipe, has insufficient information for construction. No filter is shown.</p>

- The DRD Engineer should confirm that the intake has a slow sand filter, and if not, then one should be constructed.

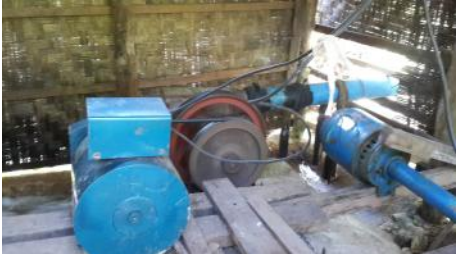
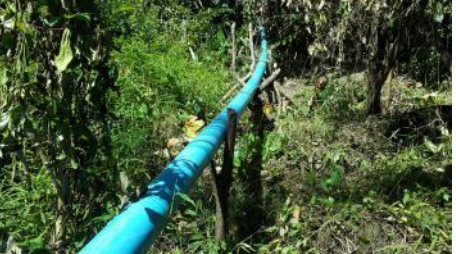
<p>Hydro generator. The old turbine was reused and the generator is new.</p>	<p>The water supply pipe is exposed, not supported securely, and is not straight.</p>

- Repair works should be carried out urgently to the eroded foundation of the reservoir tank.
- The reservoir tank should have a larger overflow to control flood waters safely.
- The water pipe supplying the turbine in Leik Kvei needs to have concrete supports.
