Ministry of Livestock, Fisheries and Rural Development
Department of Rural Development
National Community Driven Development Project
IDA Grant: H813-MM

Final Report

Technical Audit

A review of technical quality of the Sub-Projects in
the first cycle of implementation

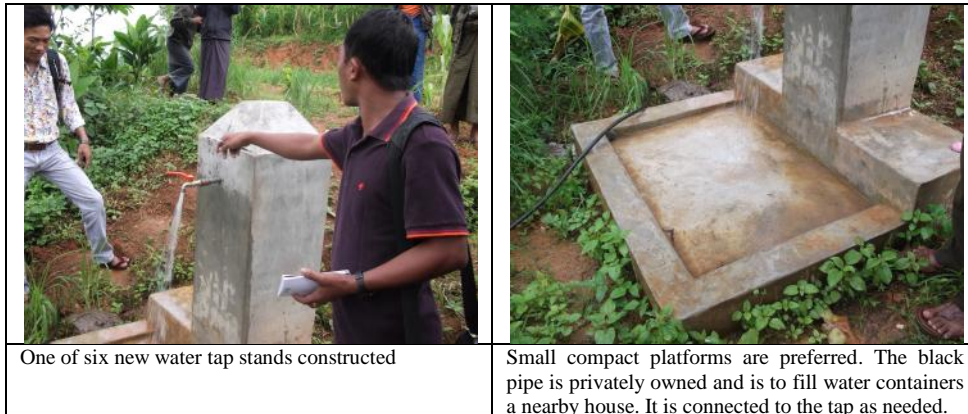
3.2 Saw Laung Water Supply, Kant Thar Yon Village Tract, Kanpetlet Township.

The SP was for the rehabilitation of an existing system originally constructed by the Government and UNDP. The new works included the construction of 6 water stands, repair of a water intake and repair of pipes. A fence was constructed around the intake to protect it. The VPSC reported that the water is not clean in the rainy season so they boil it before using for drinking. The VPSC purchased the materials required for the SP and found a Mason (local builder) from outside their village to do the construction. The TF helped with identifying construction materials of acceptable quality, and the Mason also helped check quality of materials purchased. The TF visited the SP twice during construction.

- The water tap stands should have a fence to keep animals away from the stands.
- Improvements in designs and materials should be considered (see general recommendations on water supply systems)

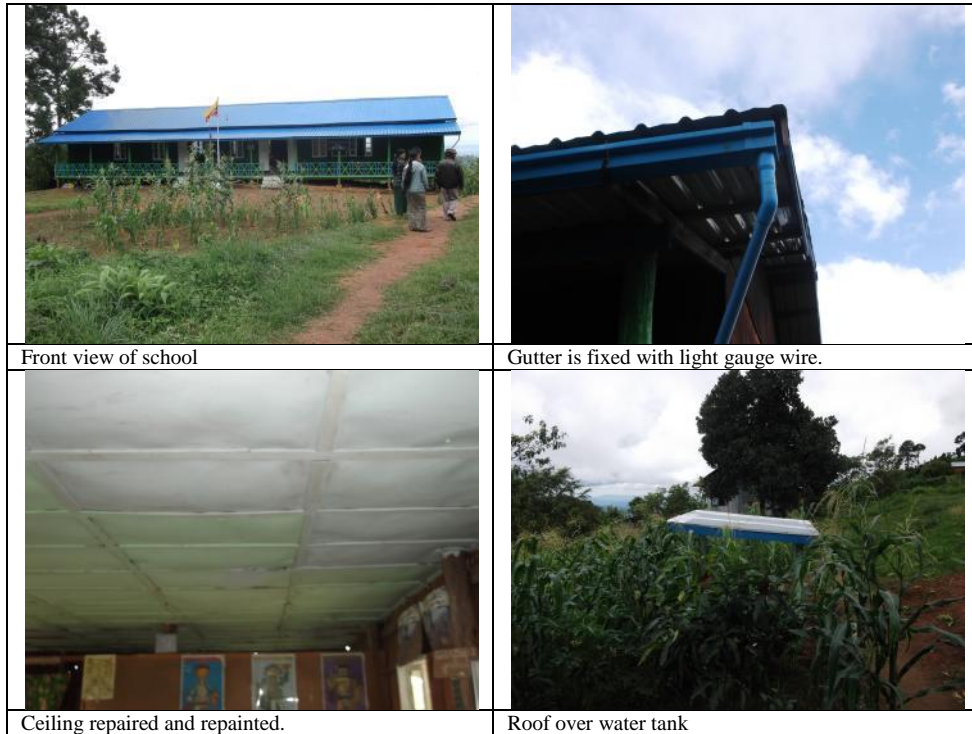
3.3 Par Kun School Rehabilitation, Kant Thar Yon Village Tract, Kanpetlet Township.

The SP was for the rehabilitation of an existing school. The roof was replaced with good quality color bond sheeting. The new timbers were hardwoods. The painting was amateurish with insufficient coats and paint spilled everywhere. Paint is expensive and the amount allowed for paint in the BOQ (95,500 MMK) was insufficient for a school this size. Additional paint was purchased for the ceiling and the back of the school was painted in dark wood stain. The guttering across the front of the school is attached using metal brackets and light gauge wire which does not look durable enough for a permanent structure.

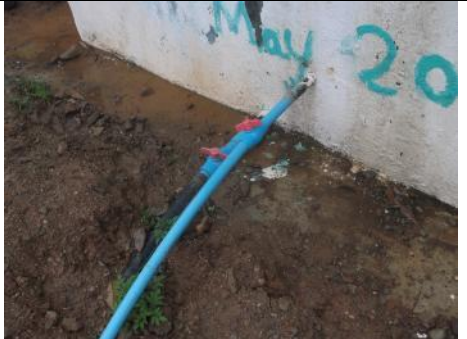
<p>Newly constructed reservoir. The tank is overflowing (it has no overflow pipe).</p>	<p>The water outlets (black pipe to the school, blue pipe to the village) are not protected and can be easily broken.</p>

The SP is technical unsatisfactory because no tap stands were constructed as part of the SP, the old pipe lines are exposed and easily broken and it does not provide a safe protected water source for the village. The constructed reservoir does not have protected fittings and has no overflow. Drawings of the reservoir do not show the details of the fittings, so the SP may be constructed according to the design, but the design is not satisfactory because it is not a complete system providing lasting benefits to the community.

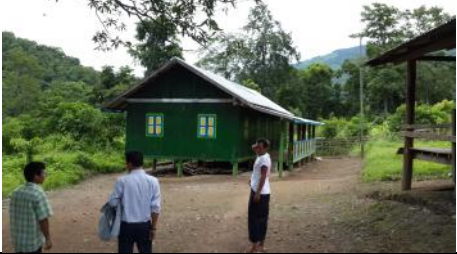
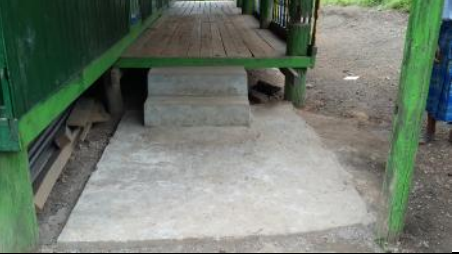
Front view of the school. The extension is at the far end of the picture.	A new entrance step was constructed by the community.

The SP constructed a one room extension to a small village primary school. The quality of the works was good, with improvements recommended in painting and fixing of the gutter. No furniture was provided by the SP.

- Furniture must be provided by the community for the extension.
- The gutter should be securely attached to the brackets provided.

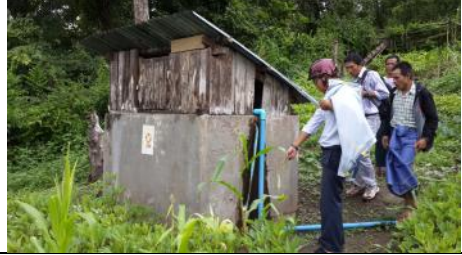
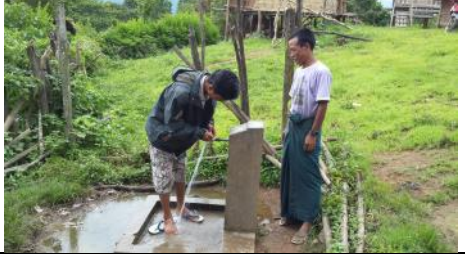
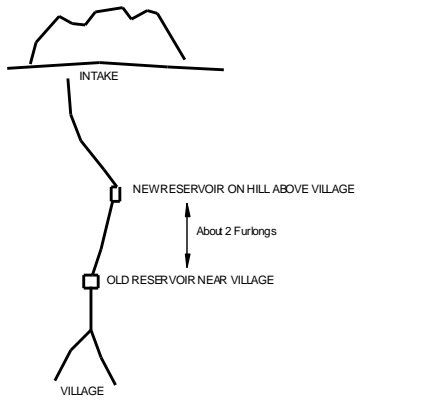
<p>Existing water reservoir showing the pipe coming from the new reservoir.</p>	<p>Existing water tap stand</p>

The VPSC reported that they have a functioning O&M system and have been able to maintain the existing system for eight years. Sometimes animals have broken the pipes, and sometimes debris has blocked pipes. They can carry out minor repairs but have limited access to spare parts. They have used bamboo to repair broken uPVC pipes.

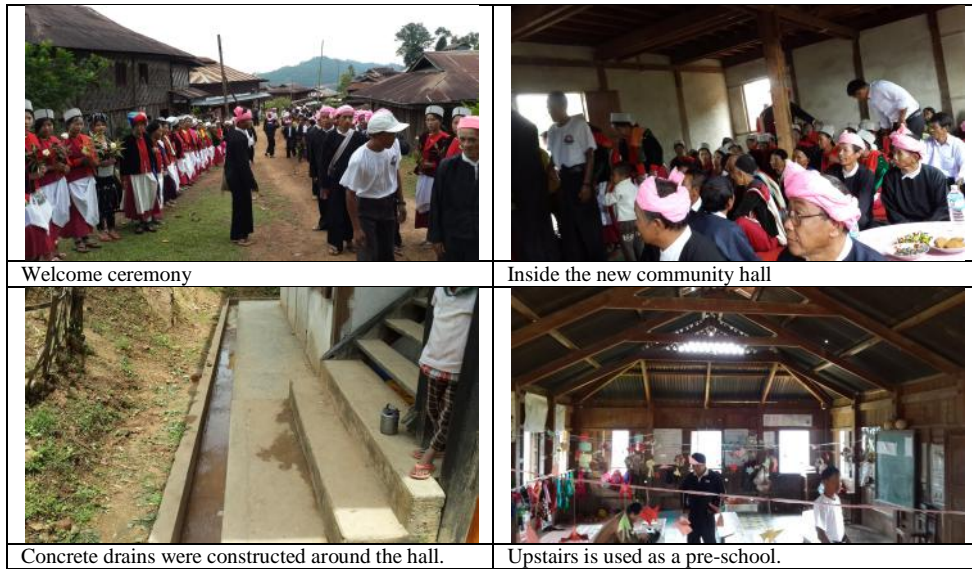
3.13 Nam Len Community Hall, Nam Len Village Tract, Namhsan Township.

The SP constructed a community hall in the space underneath a pre-school, with a concrete floor and brick walls. The existing windows were reused in the new construction with new window frames installed. Concrete drainage was provided around the building. The building was constructed by the community with no outside skilled laborers. They reported having difficulty getting three quotations for materials because the suppliers refused to sign the quotations.

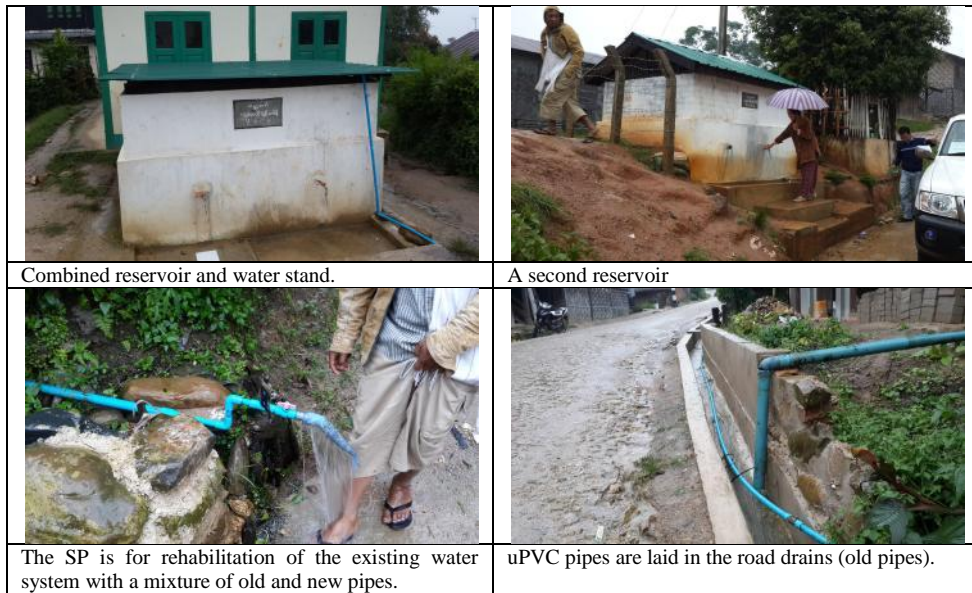
3.18 Ngun Hseng Water Tank, Ngun Hseng Village Tract, Namhsan Township

The SP is for the construction of four water reservoirs with taps in an existing pumped water system. The SP included a new electric pump, six tap and 12,000 ft of pipe. One of the reservoirs was constructed by a contractor, and the VPSC was happy with his work, but he was not interested in constructing additional tanks, so these were completed by the community. The procurement committee had difficulty purchasing sand and gravel because there was only one supplier and he could not meet the demands of all his customers.

- In all cases male and female works should be paid the same for the same work. If necessary workers can be paid by task completed, avoiding the issue of different market rates for male and female labour.
- All exposed uPVC pipes should be buried or painted to protect them from UV radiation.

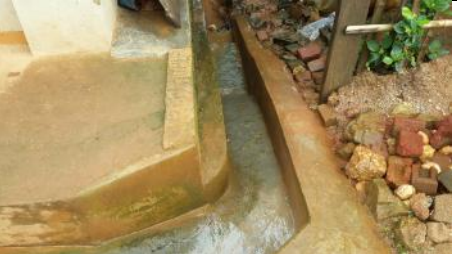
Road side drainage in village.	The runoff from the drains is diverted away from the road.

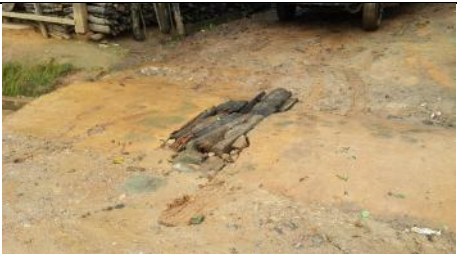
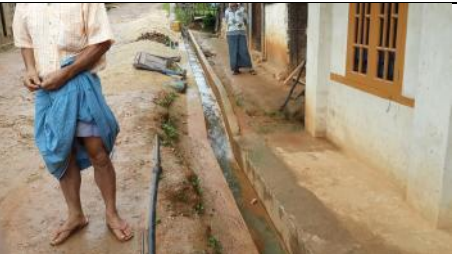
Entrances were constructed over the drain for vehicular traffic.	A section of the drain in front of a house.

- The plastering of the drains should be completed and the road surfaced.

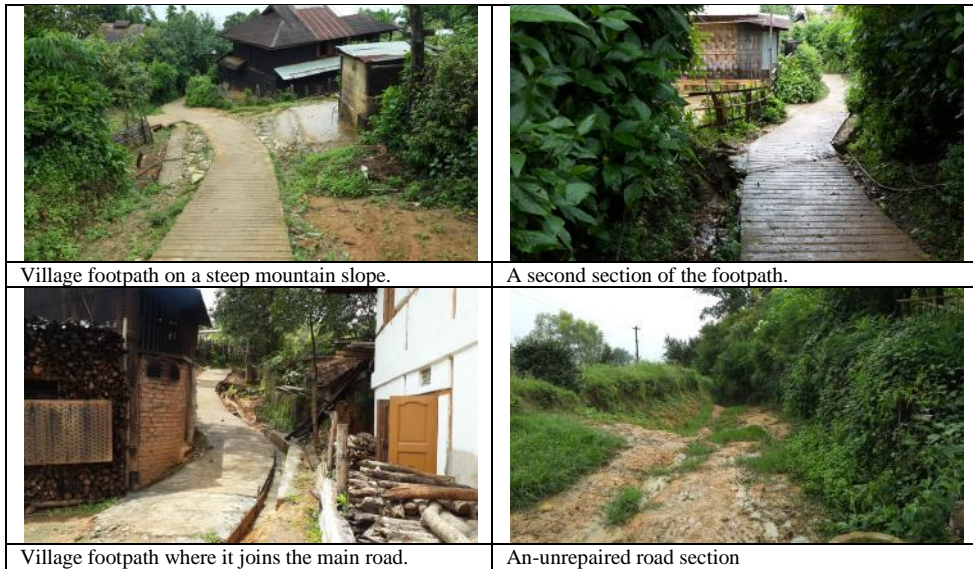
3.20 Ho Chit @ Sa Khan Thar Concrete Footpath, Man Kan Village Tract, Namhsan Township

The SP is for the construction of concrete footpaths. Three different paths were rehabilitated, two in the village and one to the school. One path remains to be completed. The village is situated on a mountain side, and before construction of the paths access from the village main road to people’s houses was very difficult, particularly for old people. In the next cycle their priority is to improve the earthen side drains with brick and to add one more sections of footpath.

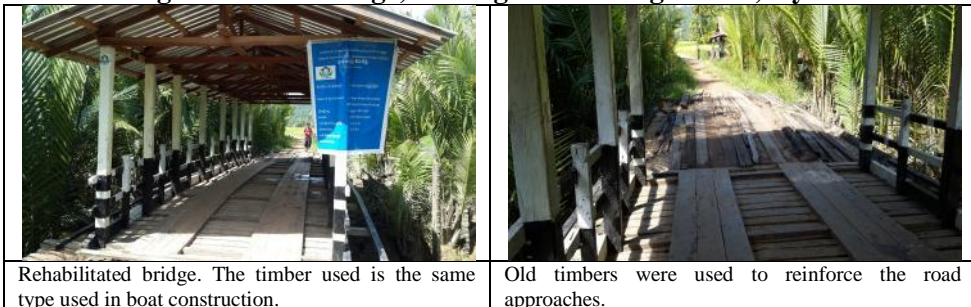
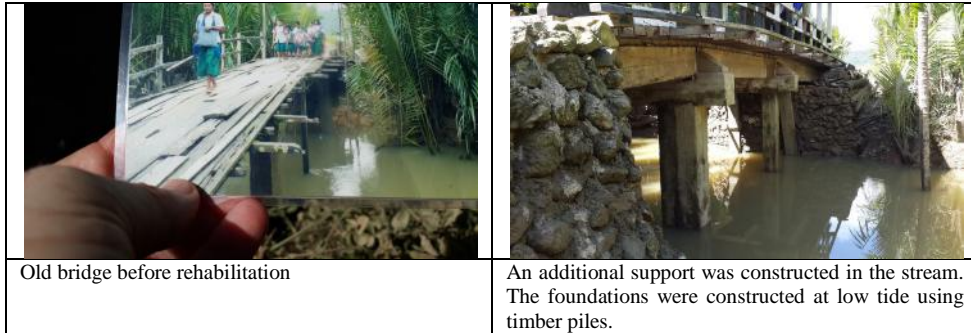
3.25 Mawng Hlaw Auk Bridge, Mawng Hiaw Village Tract, Kyunsu Township

The timber bridge was rehabilitated with two new concrete columns added, concrete beams and new timber decking. The villagers donated their labour and food for workers without charge for the construction so that they could use the money saved to construct the building over the bridge. They said this building will extend the life of the timber decking. Only skilled labors were paid.

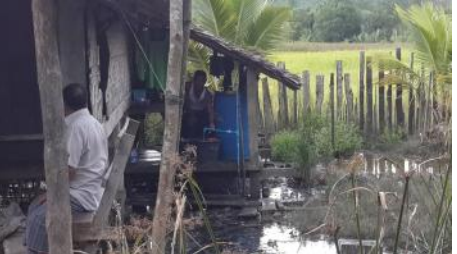
<p>The new water tank.</p>	<p>Each house has a private water connection, paid for by the users.</p>

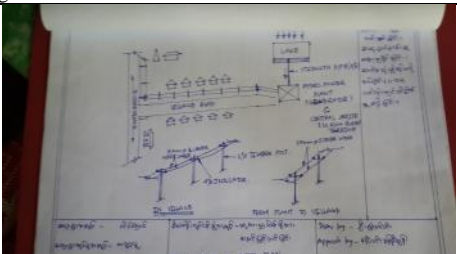
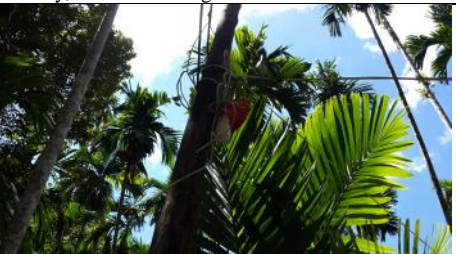
<p>The drawings for the SP were simple but contain a lot of detail.</p>	<p>A "street light" installed by the SP.</p>

- The electric wires should be replaced with insulated wires that are child safe.

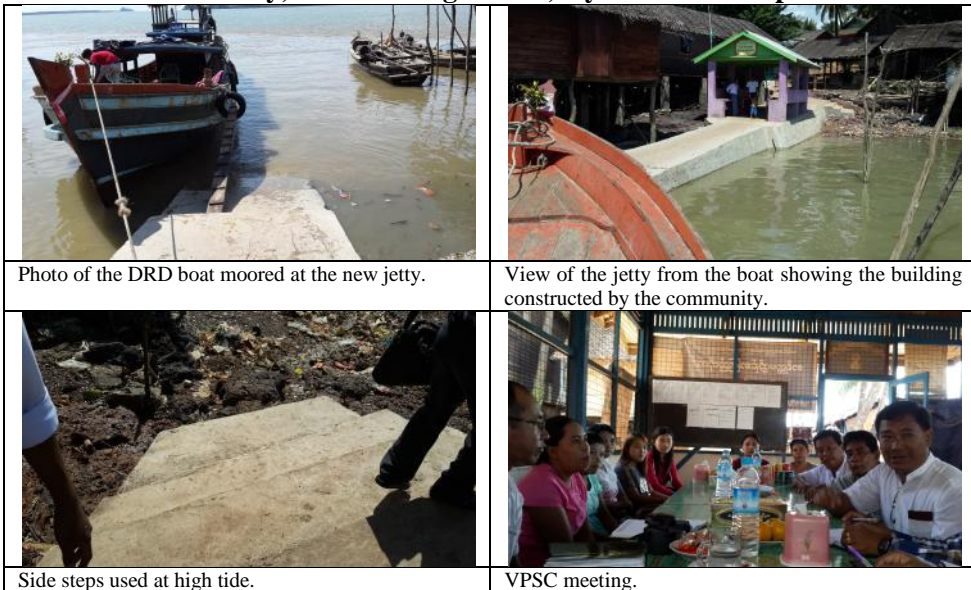
3.31 Lin Ma Lo Jetty, Ma Ai Village Tract, Kyunsu Township

A new jetty was constructed at the location of a smaller older jetty. The new jetty is 177 ft long and 6.5 ft wide. Community contribution of 1.5 million MMK was used to construct a small shelter with a bench on the jetty as shown in the photographs above. The materials were purchased using three quotes. A labour contractor from the mainland was hired to do the work, and he supplied all the tools, including a generator and pump to get water from a well for mixing concrete. The contractor re-checked all the materials required in the BOQ, so all materials were used with none left over. The contractors labors were all from Myeik, they stayed at the temple and the villagers provided them with food.

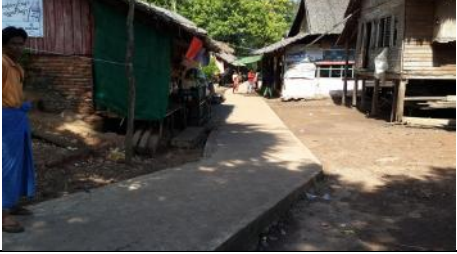
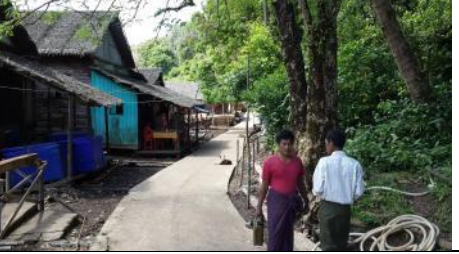
<p>View of village footpath. The path is along the edge of the island, with a hill on one side and the sea (behind the houses) on the other.</p>	<p>A second section of the new footpath</p>

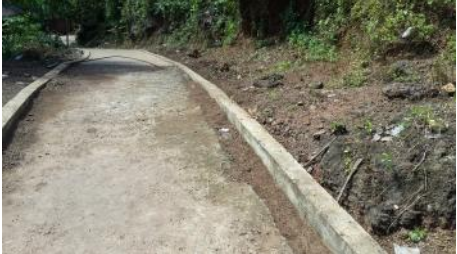
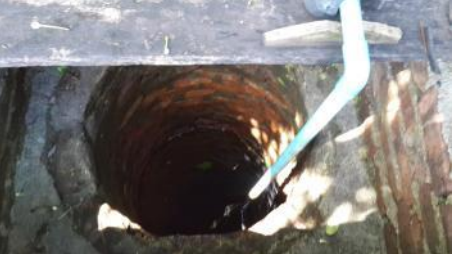
<p>The new footpath is an extension of an existing path.</p>	<p>Water supply is a problem on the small island in the dry season.</p>
